API 579 - LOCAL METAL LOSS AND PITTING CORROSION ASSESSMENT COMPARISON

ABSTRACT:

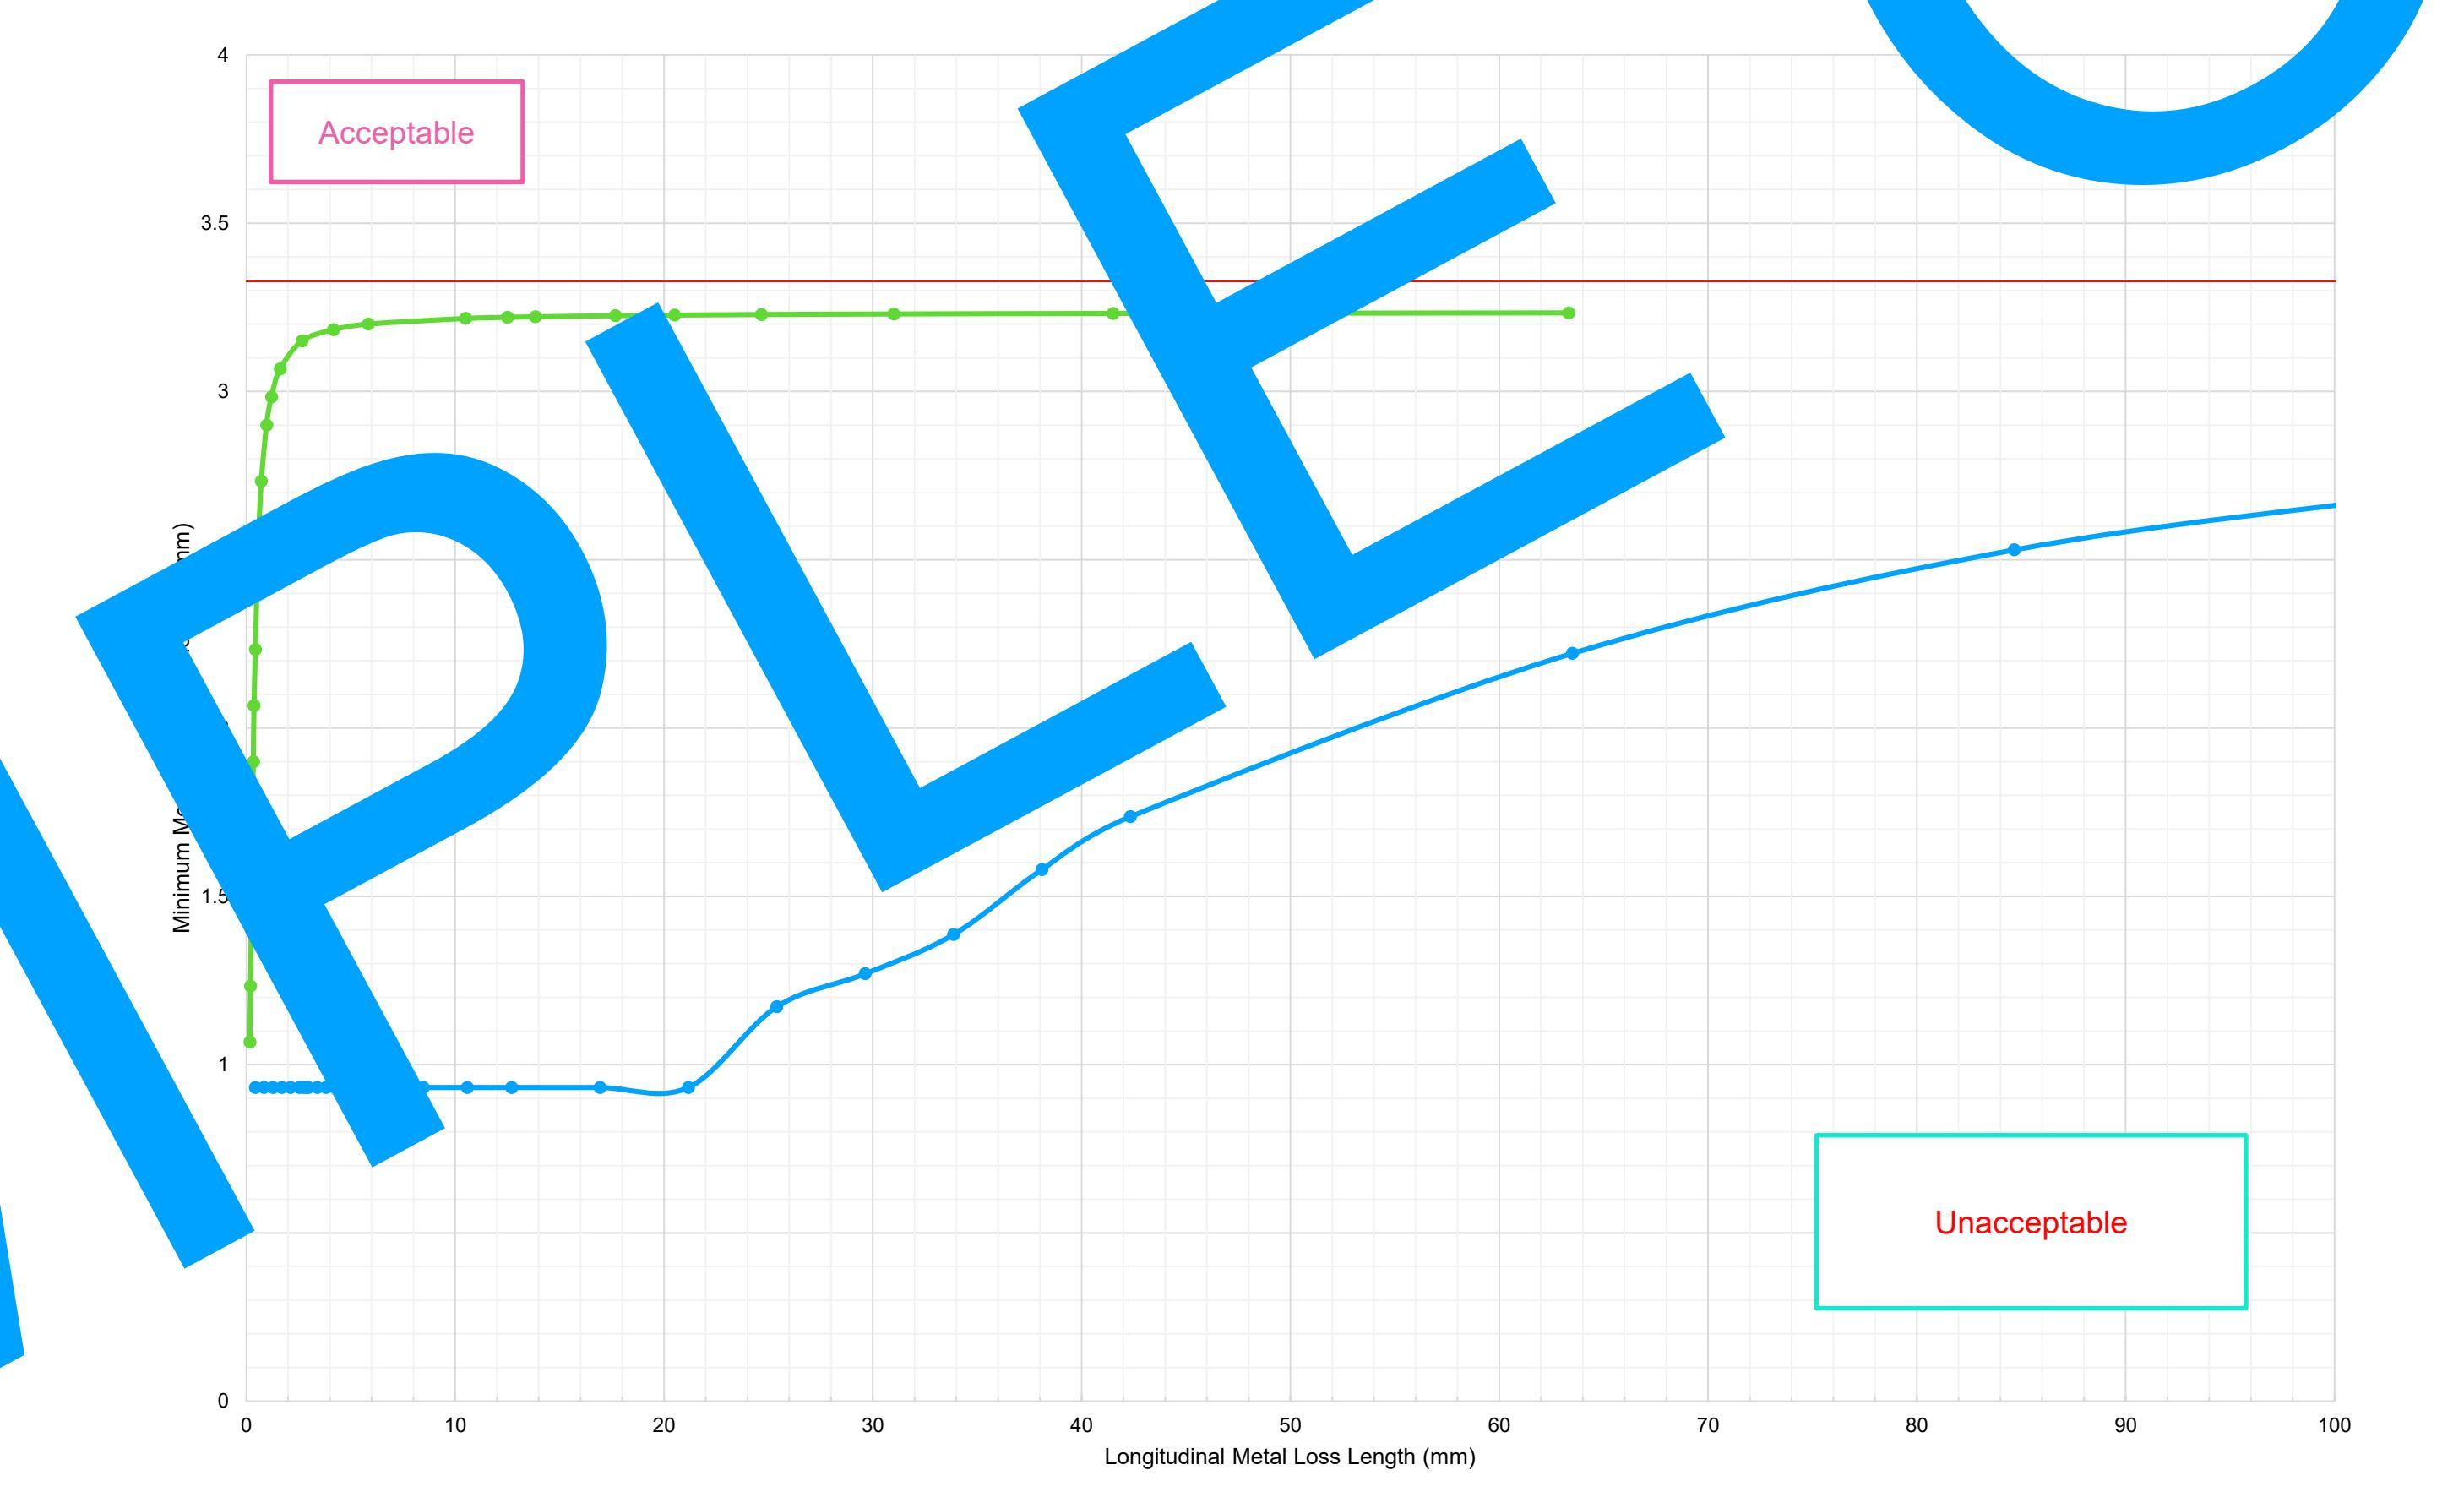
.6mm — Minimum Required Thickness + FCA — Pit Part 5 and Part 6 Le 1 Assessment

Figure 1. Acceptance Criteria of API 579 Part 5 and Part 6 Level 1 Assessment on NPS 4 pipe

For both NPS 4 and NPS 24, higher standard deviation is observed at the smaller longitudinal length of metal loss or pit diameter. The slope of Part 6 plot is steeper, reaching 90% of the maximum possible wall thickness at 10mm of the corrosion length for both NPS 4 and NPS 24 pipe. The slope of Part 5 plot reaches 90% of the maximum possible wall thickness at 300mm of the longitudinal defect length for NPS 24 pipe.

At the larger longitudinal length of metal loss or pit diameter, the standard deviation decreases, and both plots extents toward the minimum required wall thickness for the given MAWP. However, Part 5 plot of NPS 4 pipe does not reach 90% of the maximum possible wall thickness. The behaviour of the slope indicates that the pipes of smaller diameter are less tolerable to metal loss than pipes of larger diameter.

In Figure 1 and Figure 2, the smooth curve plots indicate the measure wall thickness and longitudinal length of the defect at RSF = 0.90. The area below smooth curve plots have RSF lower than 0.90 and fails Part 5 or Part 6 Level 1 Assessment. The area above smooth curve plots have RSF higher than 0.90 and passes Part 5 or Part 6 Level 1 Assessment.

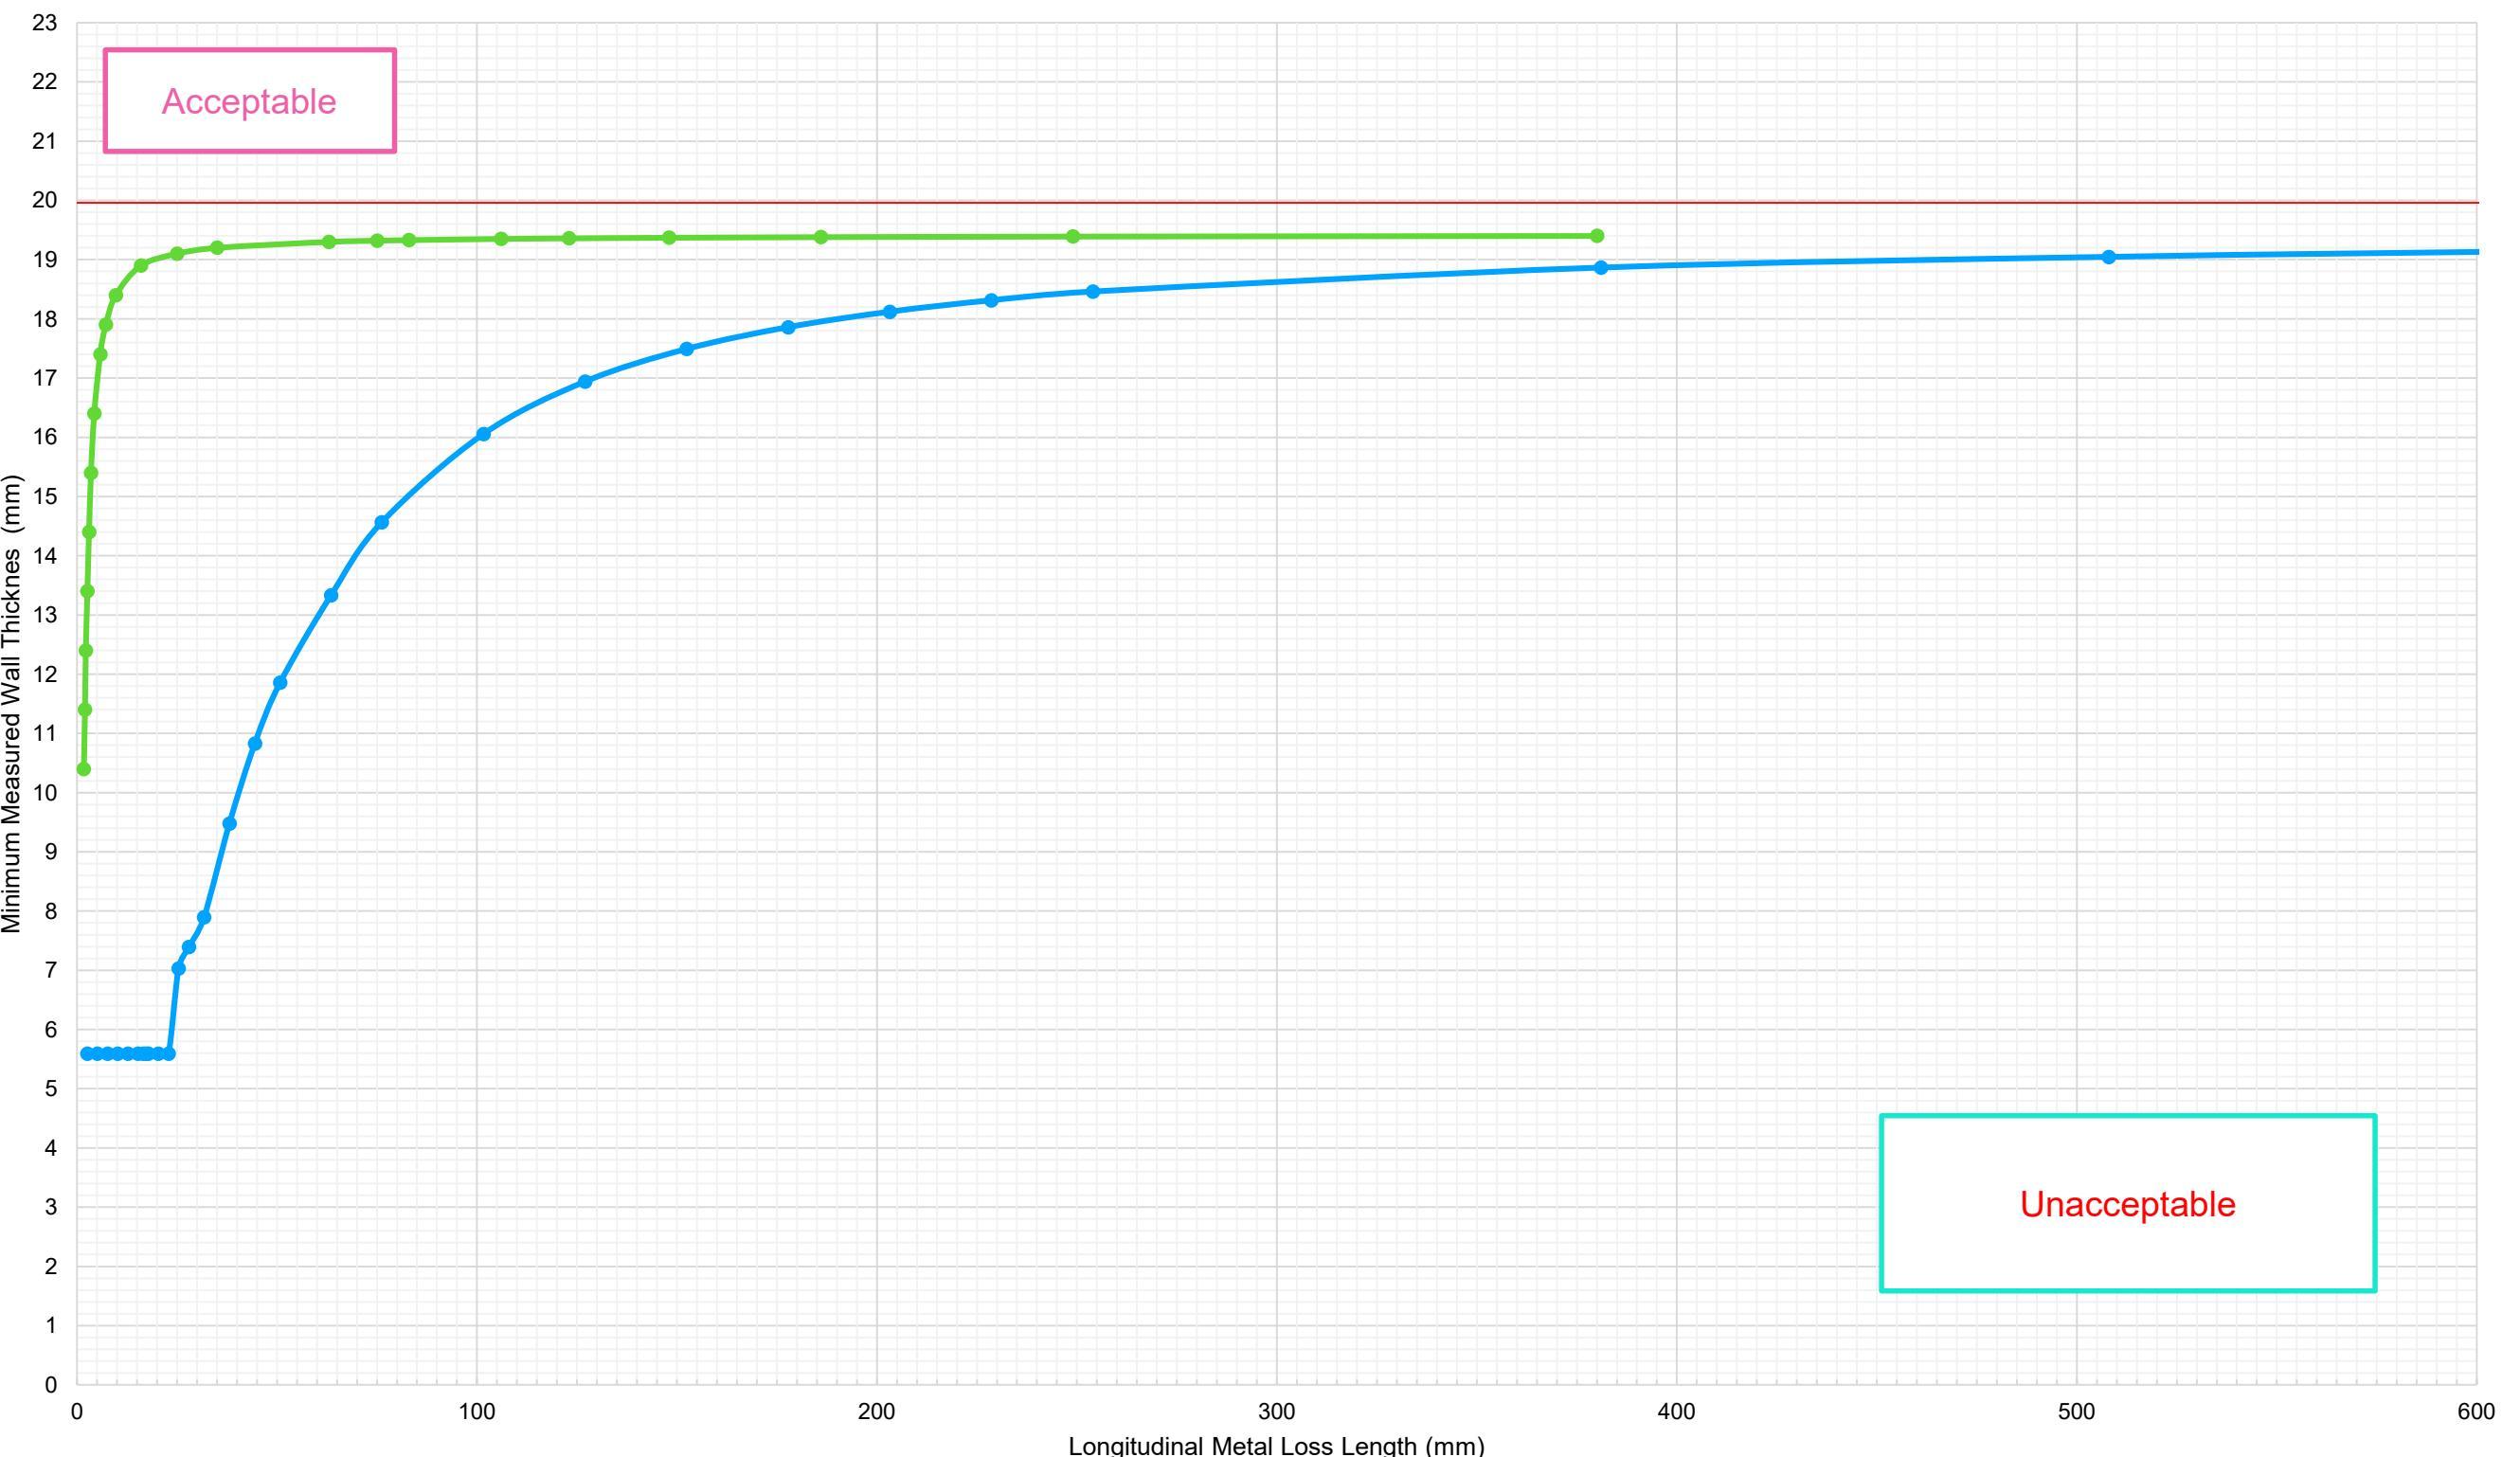
mm _____Minimum Required Thickness + FCA ____Pit Part 5 and Part 6 Level 1 Assessment NPS 24 Sch 60

Figure 2. Acceptance Criteria of API 579 Part 5 and Part 6 Level 1 Assessment on NPS 24 pipe between Part 5 and Part 6 Assessment.
